ENVIRONMENTAL MONITORING REPORT, JUNE 2020

PARRAMATTA LIGHT RAIL INFRASTRUCTURE WORKS

Project number	N81080
Document number	PLR1INF-CPBD-ALL-EN-RPT-0000012
Revision date	14 th July 2020
Revision	2

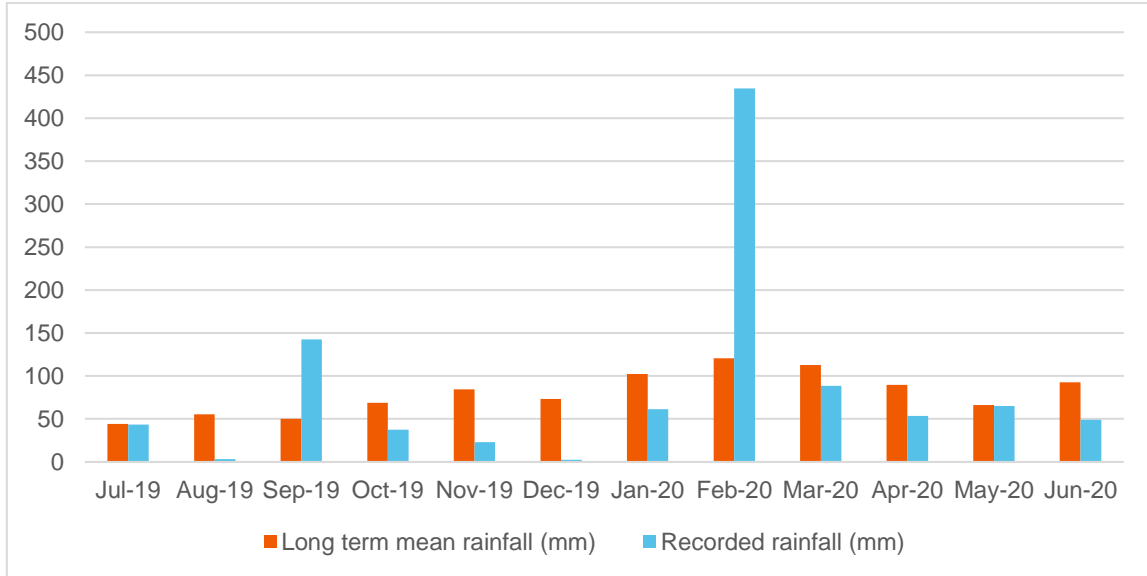
Figure 3-1 Monthly rainfall comparison

The total rainfall during the reporting period was 49 mm with 10 days with >1mm of rain and no days exceeding the 80th percentile (25.8mm) or the 85th percentile (33.1mm).

A summary of the weather observations and weather events during the reporting period of relevance to the Soil and Water Management Sub-plan and Air Quality Management Sub-Plan Trigger Action Response Plans (TARPs) are summarised in **Table 3-2**. A comparison between long term monthly means and recorded values can be found in **Figure 3-1** for rainfall and **Figure 3-2** for rain days >1mm.
