ENVIRONMENTAL MONITORING REPORT, JULY 2020

PARRAMATTA LIGHT RAIL INFRASTRUCTURE WORKS

25 July 2020

Parramatta
Connect

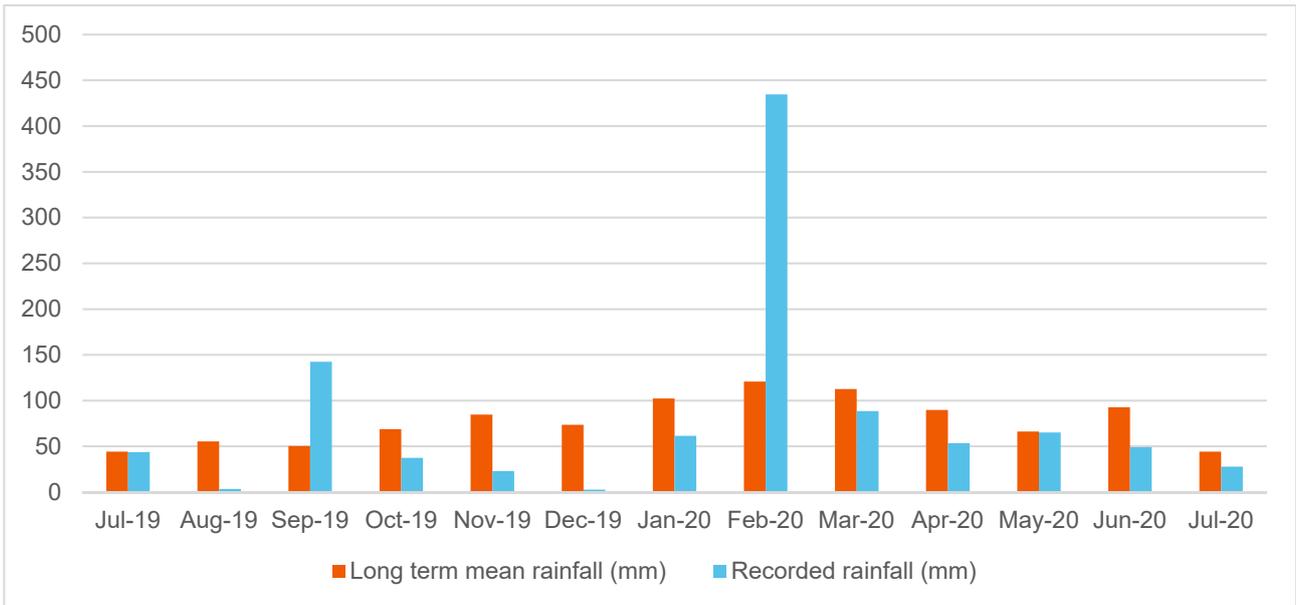
Figure 3-1 Monthly rainfall comparison

A summary of the weather observations and weather events during the reporting period of relevance to the Soil and Water Management Sub-plan and Air Quality Management Sub-Plan Trigger Action Response Plans (TARPs) are summarised in **Table 3-2**. A comparison between long term monthly means and recorded values can be found in **Figure 3-2**.
