# ENVIRONMENTAL MONITORING REPORT, AUGUST 2020

## PARRAMATTA LIGHT RAIL INFRASTRUCTURE WORKS

4 September 2020

| <b>Document number</b> | PLR1INF-CPBD-ALL-EN-RPT-0000014 |

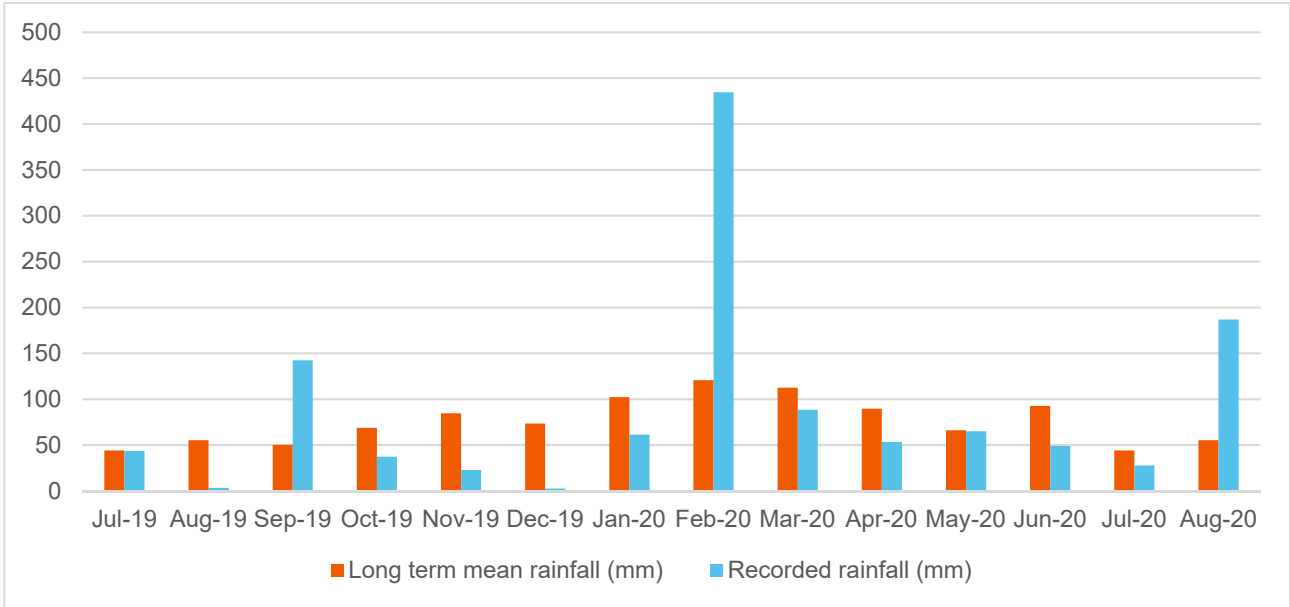
**Figure 3-1 Monthly rainfall comparison**

The total rainfall during the reporting period was 186.8 mm with 9 days with >1mm of rain with two days exceeding the 80<sup>th</sup> percentile (25.8mm) and one day exceeding the 85<sup>th</sup> percentile (33.1mm).

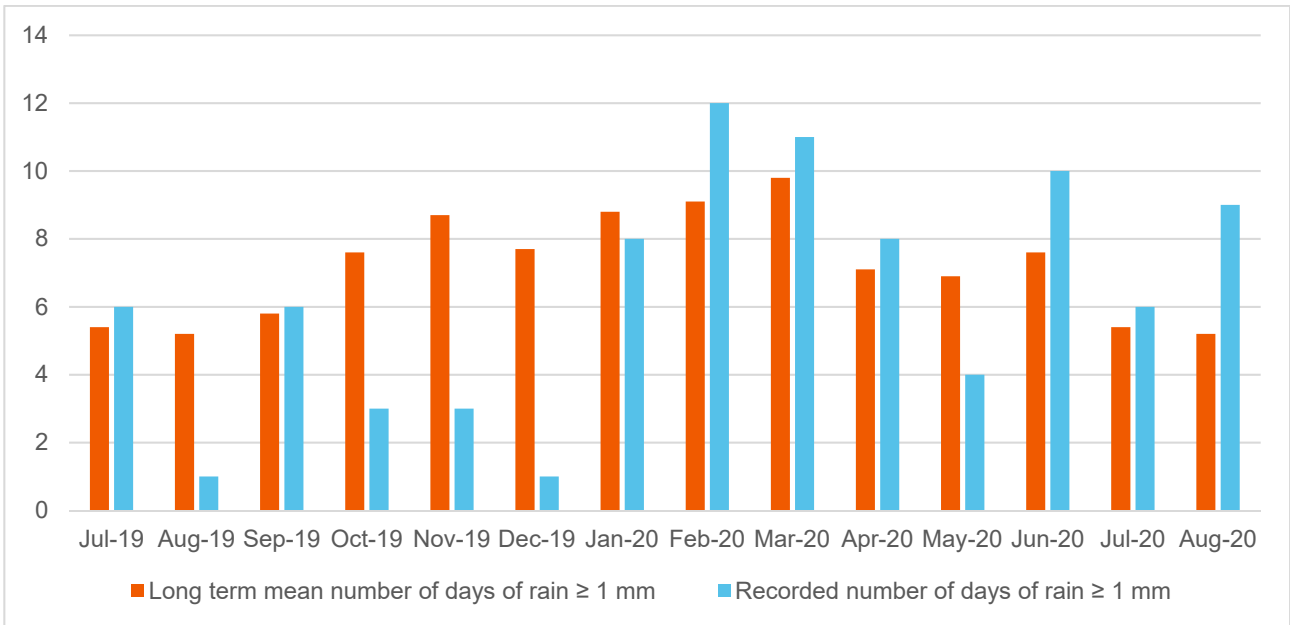
**Figure 3-2 Monthly rain days comparison**

A summary of the weather observations and weather events during the reporting period of relevance to the Soil and Water Management Sub-plan and Air Quality Management Sub-Plan Trigger Action Response Plans (TARPs) are summarised in **Table 7-2**. A comparison between long term monthly means and recorded values can be found in **Figure 3-2**.
