# ENVIRONMENTAL MONITORING REPORT, SEPTEMBER 2020

## PARRAMATTA LIGHT RAIL INFRASTRUCTURE WORKS

25 September 2020

<b>Project number</b>	<b>N81080</b>
<b>Document number</b>	PLR1INF-CPBD-ALL-EN-RPT-0000016
<b>Revision date</b>	25 September 2020
<b>Revision</b>	0

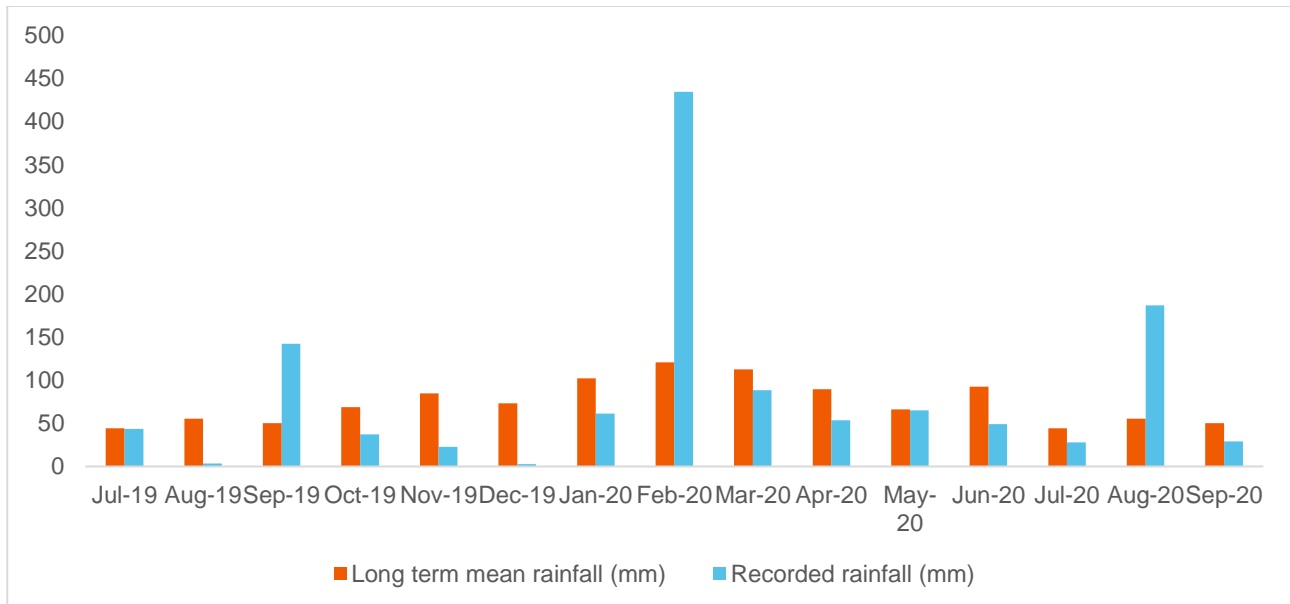
**Figure 3-1 Monthly rainfall comparison**

The total rainfall during the reporting period was 29.2mm with six days with over 1mm of rain. No rain events exceeded the 80<sup>th</sup> percentile (25.8mm) or the 85<sup>th</sup> percentile (33.1mm).

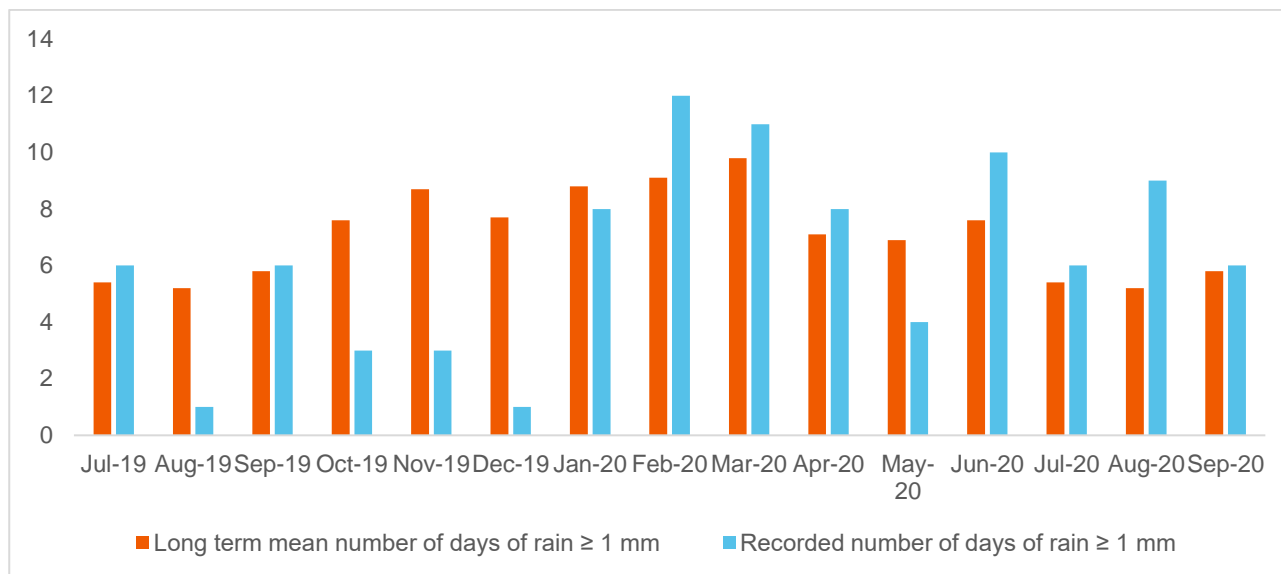
**Figure 3-2 Monthly rain days comparison**

Plans (TARPs) are summarised in **Table 7-2**. A comparison between long term monthly means and recorded values can be found in **Figure 3-2**.
