ENVIRONMENTAL MONITORING REPORT, JANUARY 2021

PARRAMATTA LIGHT RAIL INFRASTRUCTURE WORKS

5 February 2021

Project number	N81080
Document number	PLR1INF-CPBD-ALL-EN-RPT-0000020
Revision date	5 February 2021
Revision	0

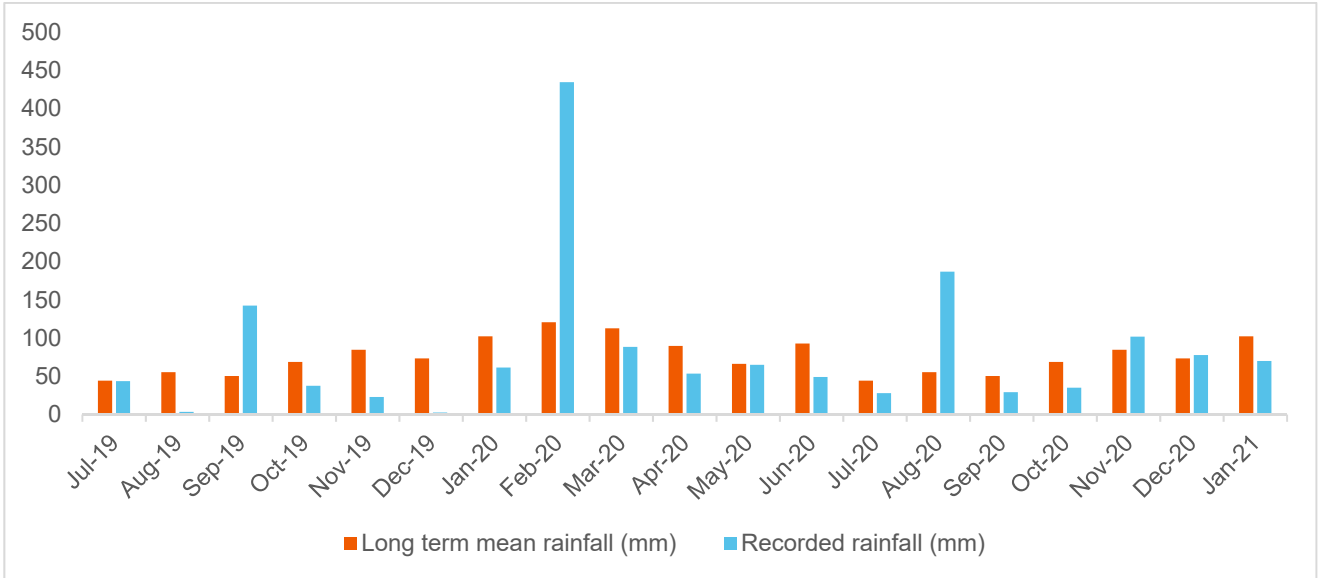
Figure 3-1 Monthly rainfall comparison

The total rainfall recorded during the reporting period was 70 mm with ten days exceeding one millimetre of rain. No rain events exceeded the 80th percentile (25.8mm) nor the 85th percentile (33.1mm).
